Contract #: 04-0120F4Cty: SF/ALA Rte: 80 PM: 13.2/13.9File #: 99.28**WELDING INSPECTION REPORT****Resident Engineer:** Pursell, Gary**Address:** 333 Burma Road**City:** Oakland, CA 94607**Report No:** WIR-003090**Date Inspected:** 25-Jun-2008**Project Name:** SAS Superstructure**OSM Arrival Time:** 2300**Prime Contractor:** American Bridge/Fluor Enterprises, a JV**OSM Departure Time:** 700**Contractor:** Japan Steel Works, Ltd.**Location:** Muroran, Japan**CWI Name:** Anthony Carrado**CWI Present:** Yes No**Inspected CWI report:** Yes No N/A**Rod Oven in Use:** Yes No N/A**Electrode to specification:** Yes No N/A**Weld Procedures Followed:** Yes No N/A**Qualified Welders:** Yes No N/A**Verified Joint Fit-up:** Yes No N/A**Approved Drawings:** Yes No N/A**Approved WPS:** Yes No N/A**Delayed / Cancelled:** Yes No N/A**Bridge No:** 34-0006**Component:** Tower, Jacking and Deviation Saddles**Summary of Items Observed:**

On this date OSM Quality Assurance (QA) Representative Daniel L. Reyes was present during the welding of the structural steel components of the West Deviation Saddles relative to this project. The following was observed:

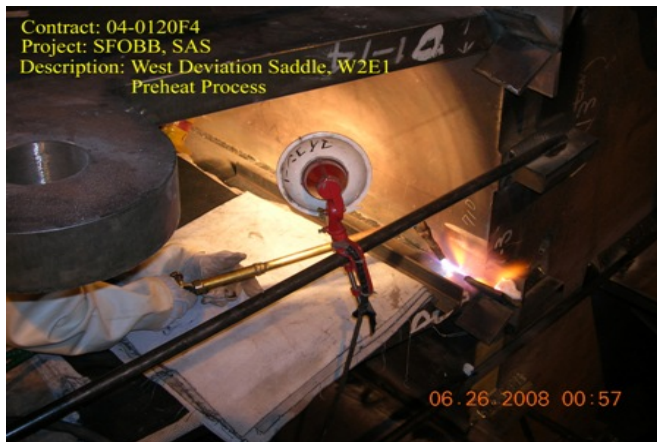
At the start of the C-shift the QA inspector traveled to the Fabrication Shop # 4 to observe the continued Partial Joint Penetration (PJP) groove welding of the structural steel plate components for the West Deviation Saddle identified as W2E1. The Welding Procedure Specification (WPS) SJ-3011-2 and the Distortion Control Plan Document Number SJ-3109 Rev. 1 was utilized by the Japan Steel Works, Ltd. (JSW) personnel during the performance of the production welding of the end plate to base plate connections. The WPS was also used as a reference by the QC inspector during the verification of the welding parameters. The welding was performed in the Flat Position (1G) with the work in the horizontal plane and the weld metal deposited from above. The gas shielded Flux Cored Arc Welding (FCAW-G) process was utilized and the welding performed by JSW personnel Mutuo-Kashiwada ID 08-2008 and Kouzou Kabayashi ID 08-5023. The PJP welding appeared to be performed as per Step 4, Attachment 6 of the JSW Distortion Control Plan Revision 1.

The QC inspector verified the minimum preheat temperatures of 160 degrees Celsius and at the conclusion of verifying the preheat temperatures the QC inspector verified the DC welding parameters and was observed as follows for the welder Kouzou-Kobayashi , 330 amps and 36.0 volts with a travel speed measured at 310 mm/m and for the welder Mutuo-Kashiwada, 330 amps and 36.0 volts with a travel speed measured at 254 mm/m. The welding, inspection and the verification tasks were performed on the weld joints identified as E1Y-11L and E1Y-12L.
